**FINAL
POST-CONSTRUCTION SUMMARY REPORT
BUILDING 66 REMEDIAL EXCAVATION
NAVAL STATION TREASURE ISLAND PETROLEUM REMEDIAL EXCAVATION PROGRAM
YERBA BUENA ISLAND
SAN FRANCISCO, CALIFORNIA**

**Environmental Remedial Action
Contract Number N62474-98-D-2076
Contract Task Order 0036**

**Document Control Number 5001
Revision 0**

December 11, 2002

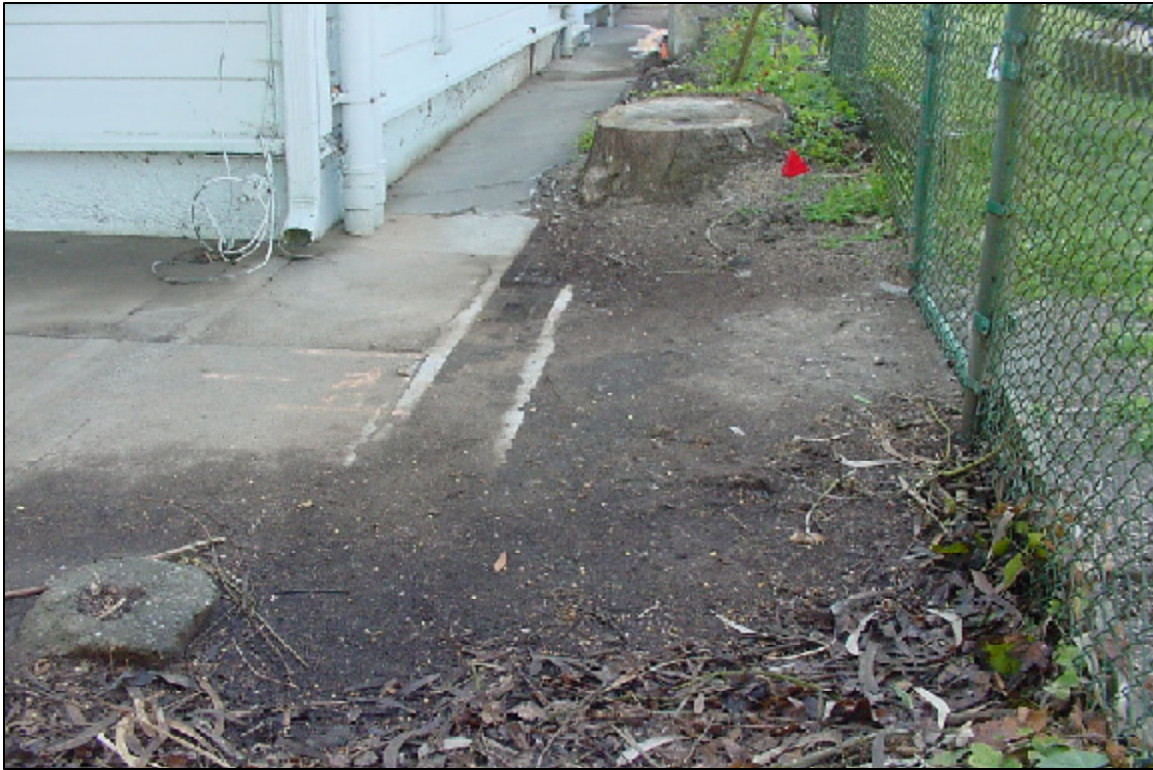
During lead-soil characterization sampling in March 2001, IT observed evidence of petroleum around the perimeter of Building 66. Soil staining and a strong petroleum odor were noted on

both the northwestern corner and western side of the building ([Photographs 1, 2, and 3](#)). A visible petroleum sheen was also found on standing water on the concrete sidewalk adjacent to the building (on the southern and western side) ([Photograph 4](#)).

Photograph 1: View looking south of stained soil areas. Strong petroleum odor detected in soil on both sides of fence (playground on western side of fence).

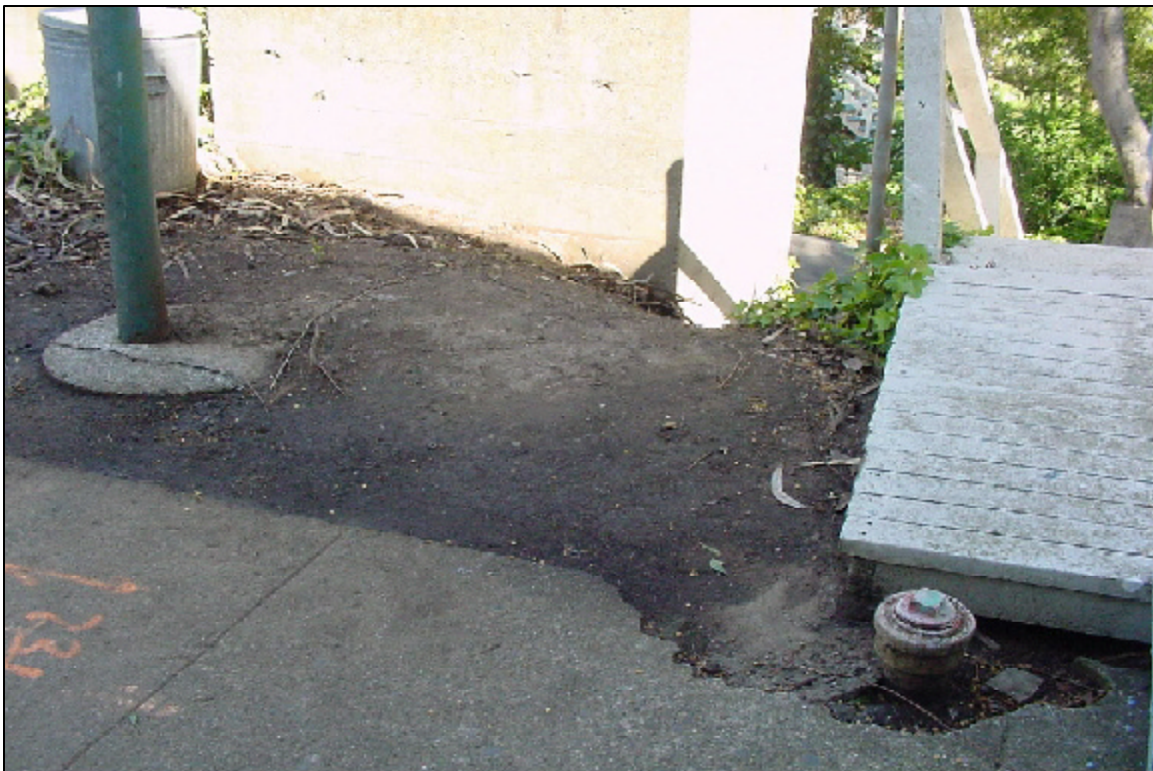
Photograph 2: View looking north toward catch basin. Stained soil had a strong petroleum odor.

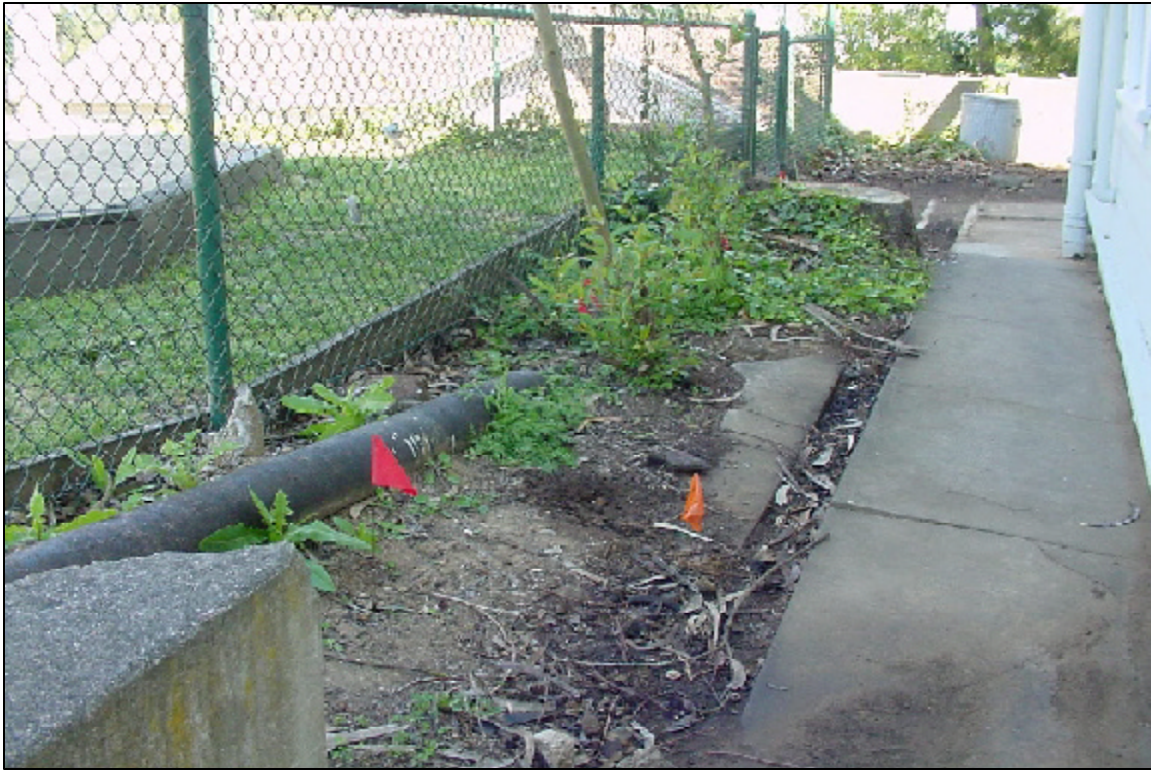
Photograph 3: View looking north along west side of building. Soil at this location had a strong petroleum odor.

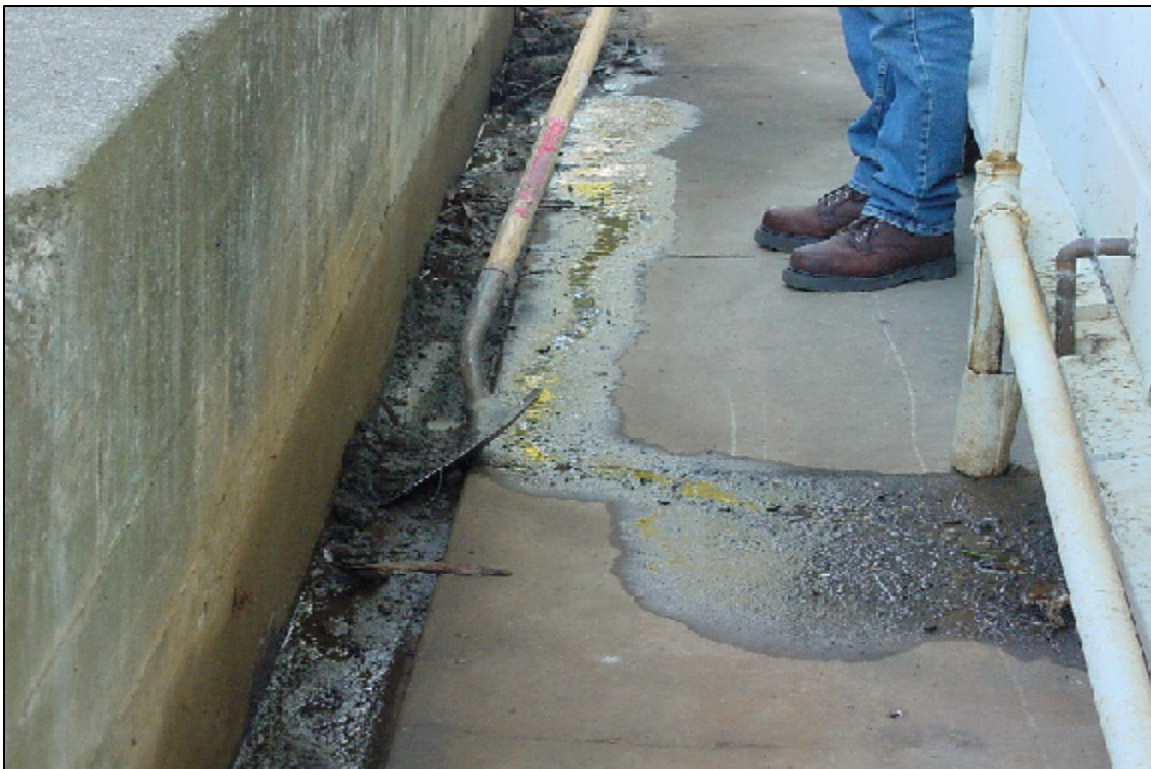
Photograph 4: View of concrete drain along western side of building. Water in this drain had a slight oily sheen.

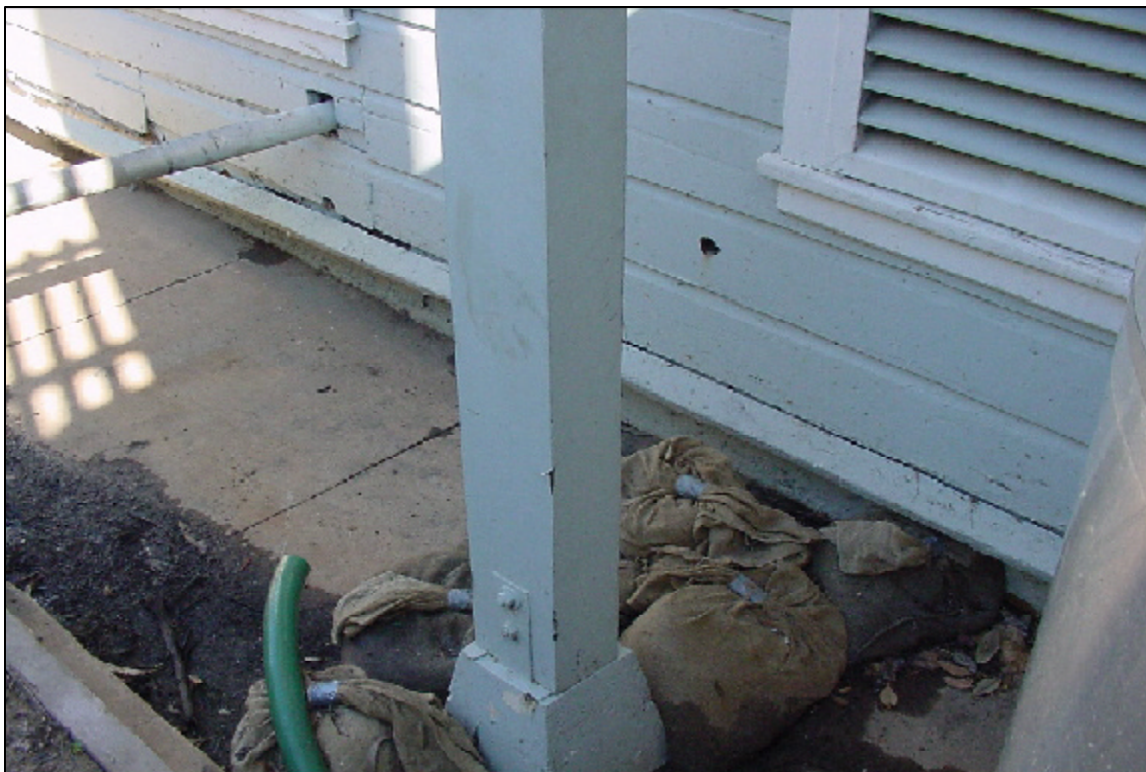
Photograph 5: Sandbags placed to absorb petroleum product on the southern side of Building 66.

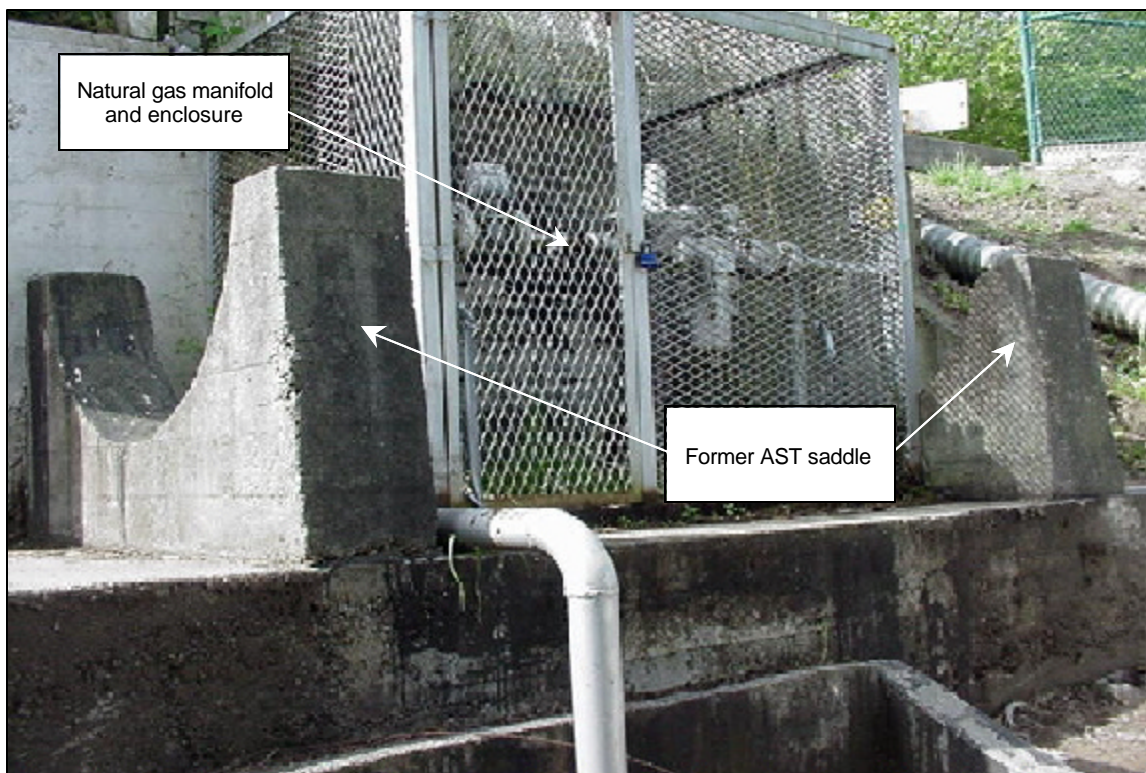
Photograph 6: Location of former AST and natural gas manifold.

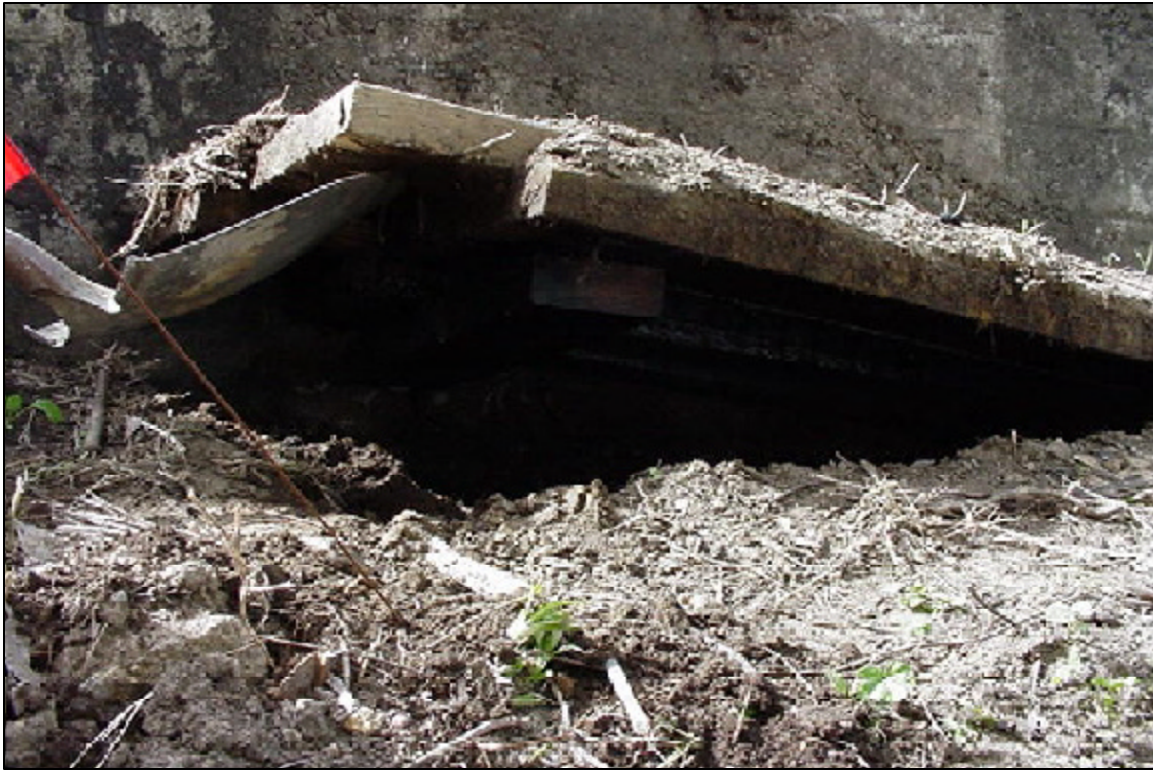
Photograph 7: View looking south into vault overlying the previously undocumented UST. Obvious petroleum odor and staining were observed on wood cover.

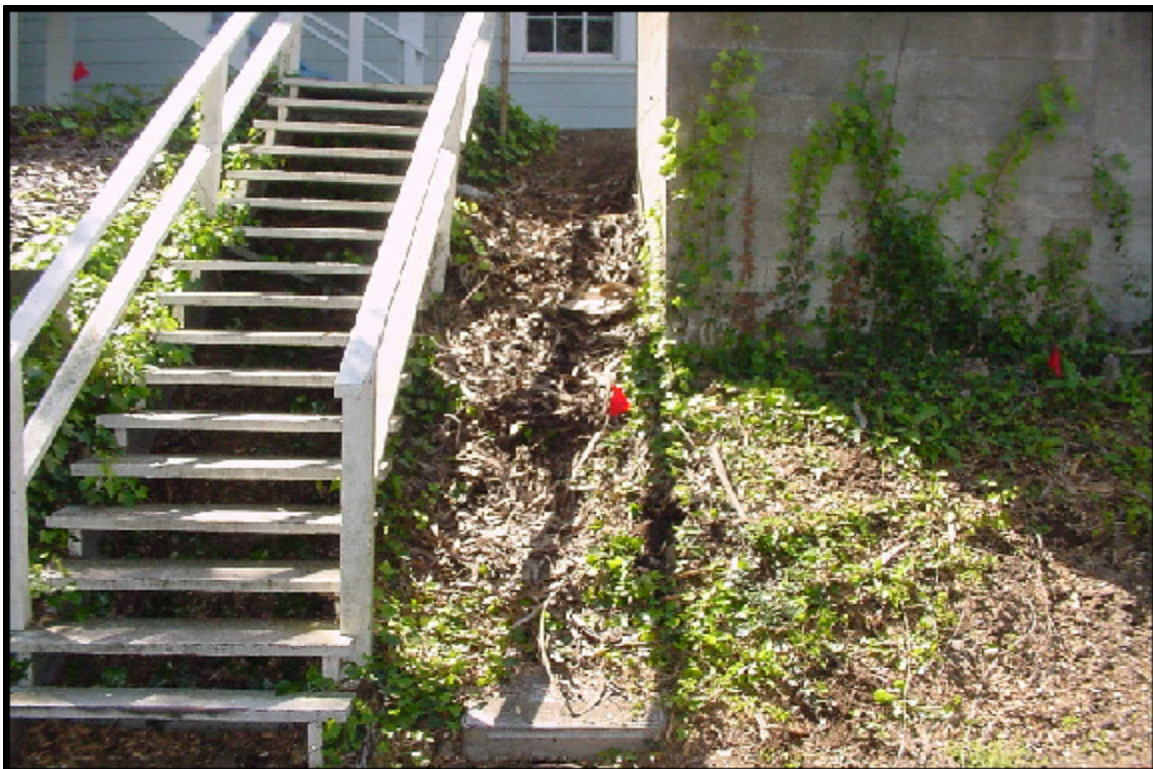
Photograph 8: View looking south at western stairway and catch basin. Obvious petroleum odor was noted between stairway and basin.

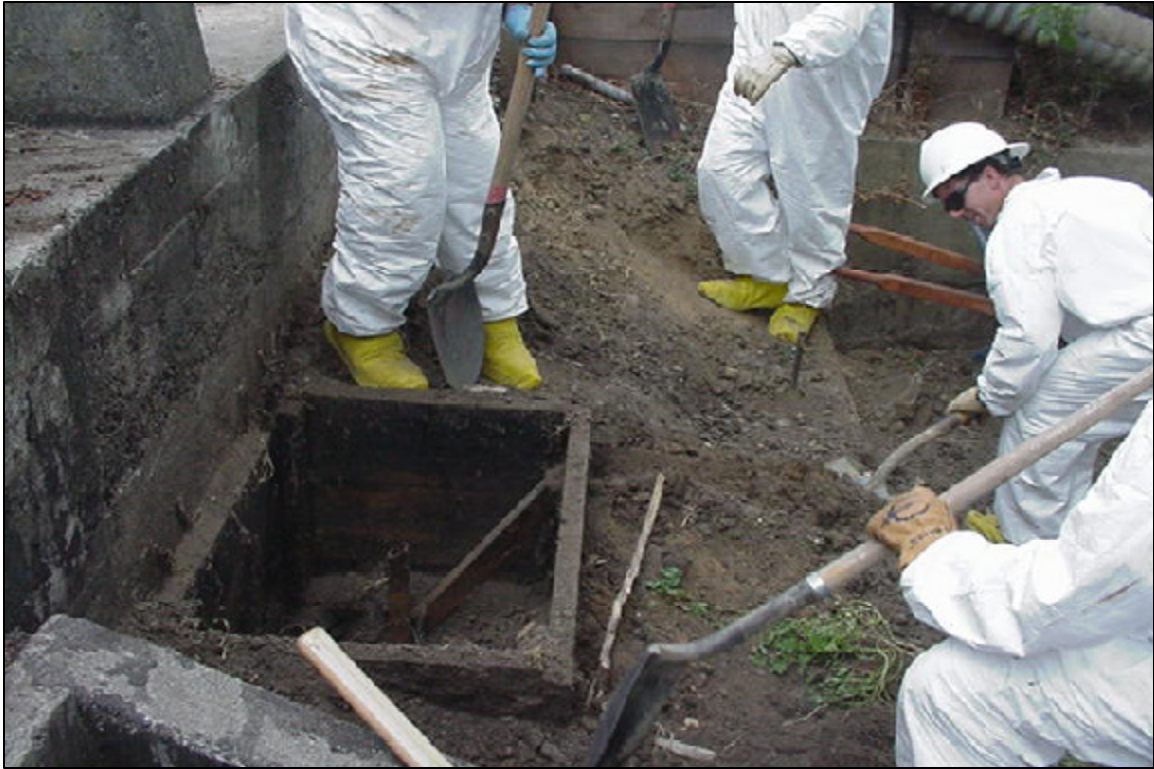
Photograph 9: Excavation around wooden vault above discovered UST.

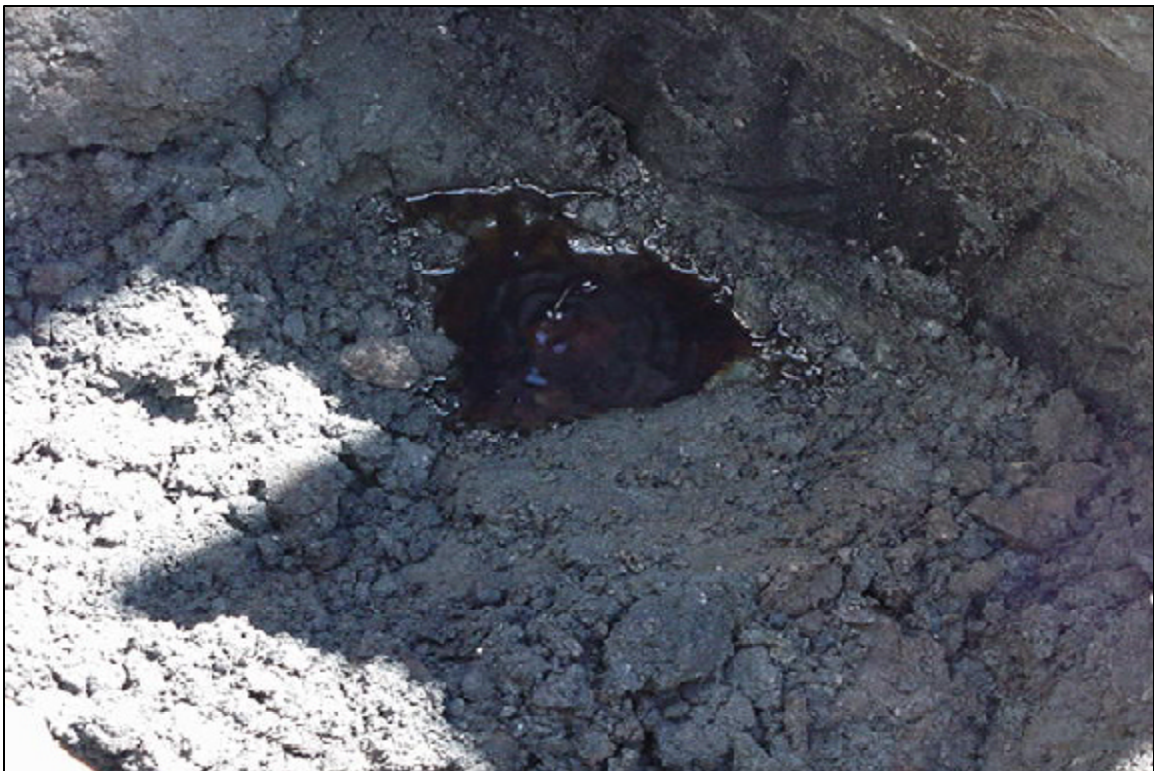
Photograph 10: Petroleum infiltrating the wooden vault excavation.

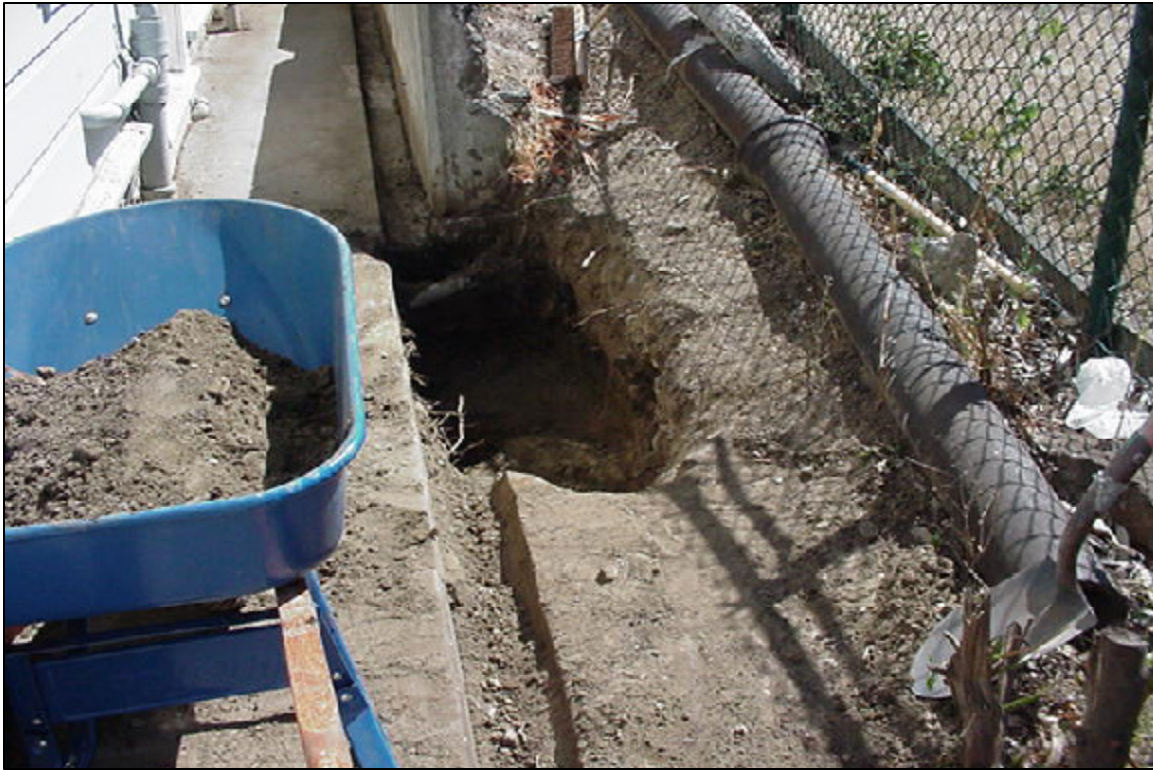
Stained and odiferous TPH-contaminated soil along the western side of Building 66 was excavated by hand digging to a depth of approximately 2 feet bgs ([Photograph 11](#)) (see

Photograph 11: West wall excavation.

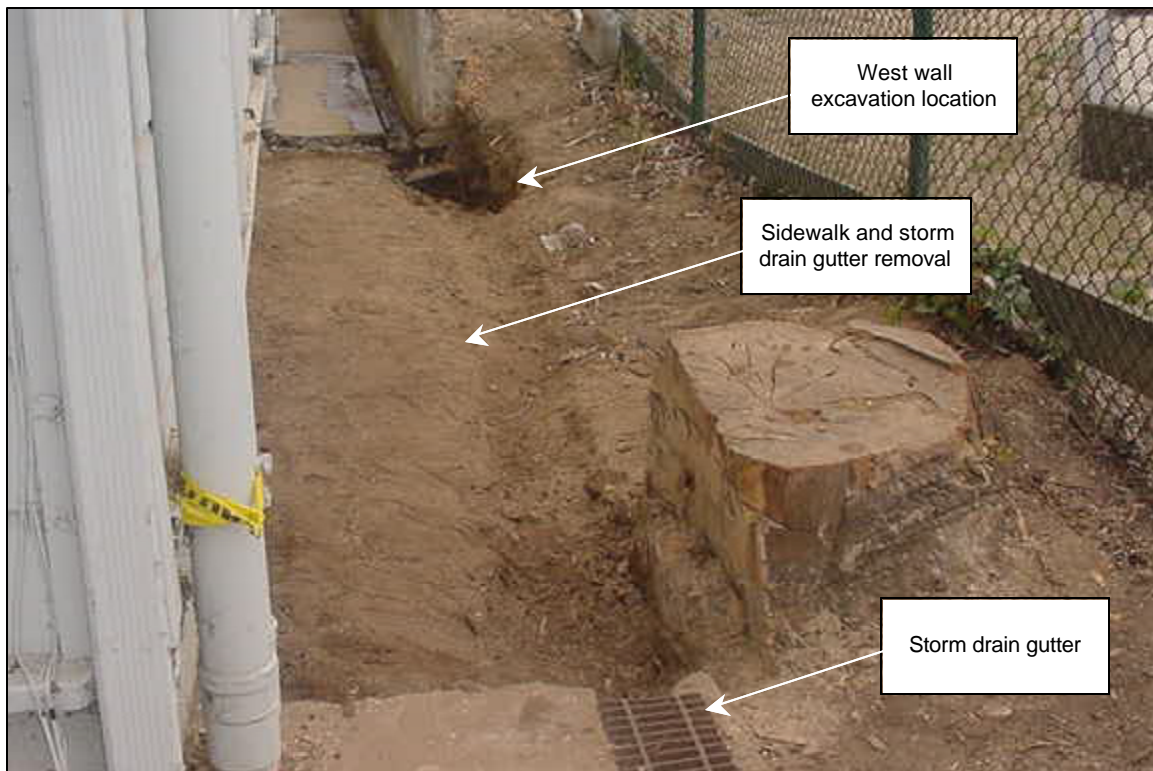
[Figure 2](#)). A previously damaged sidewalk and storm drain gutter were also removed from this excavation area ([Photograph 11a](#)). The damaged sidewalk was removed to facilitate restoration of the storm drain gutter along the west side of the building. Upon completion of excavation, the sidewalk and gutter were replaced from the end of the retaining wall to the northwest corner of the building (see [Section 4.2, “Surface Restoration”](#)).

Photograph 11a: View of west wall excavation, removed concrete sidewalk, and storm drain gutter.

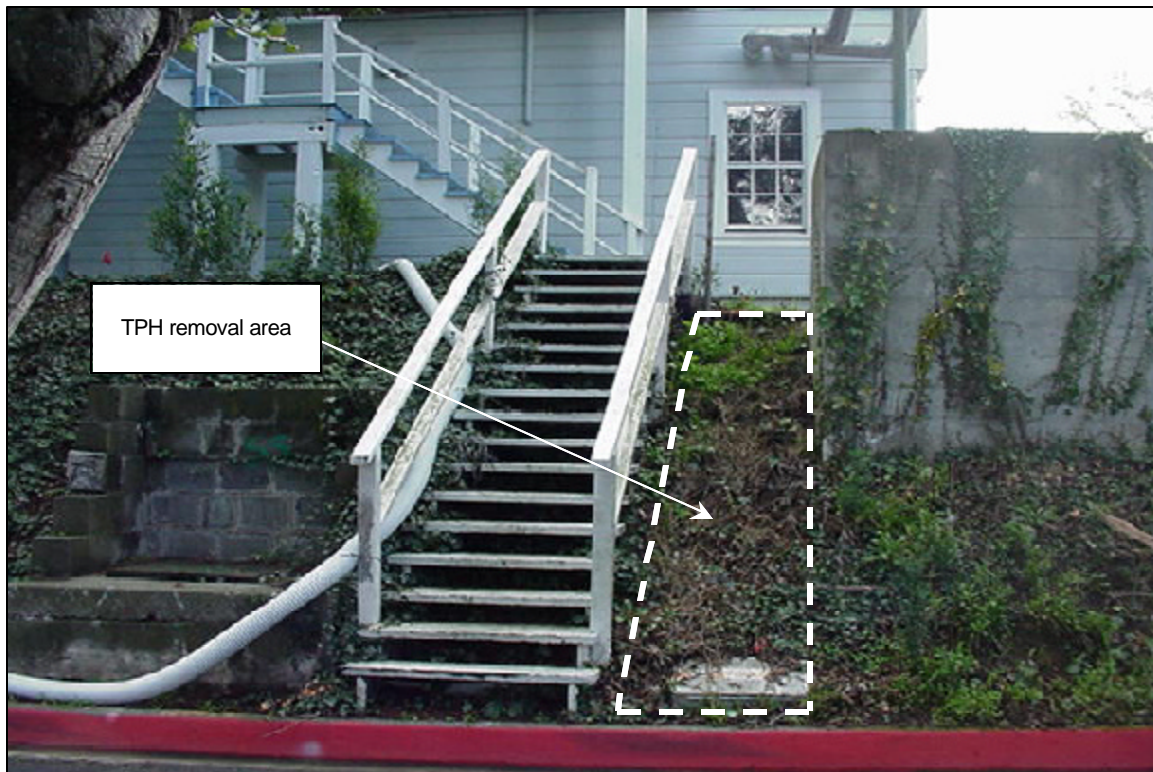
Photograph 12: View of TPH removal area between the wooden stairway and catch basin at the northwest corner of Building 66.

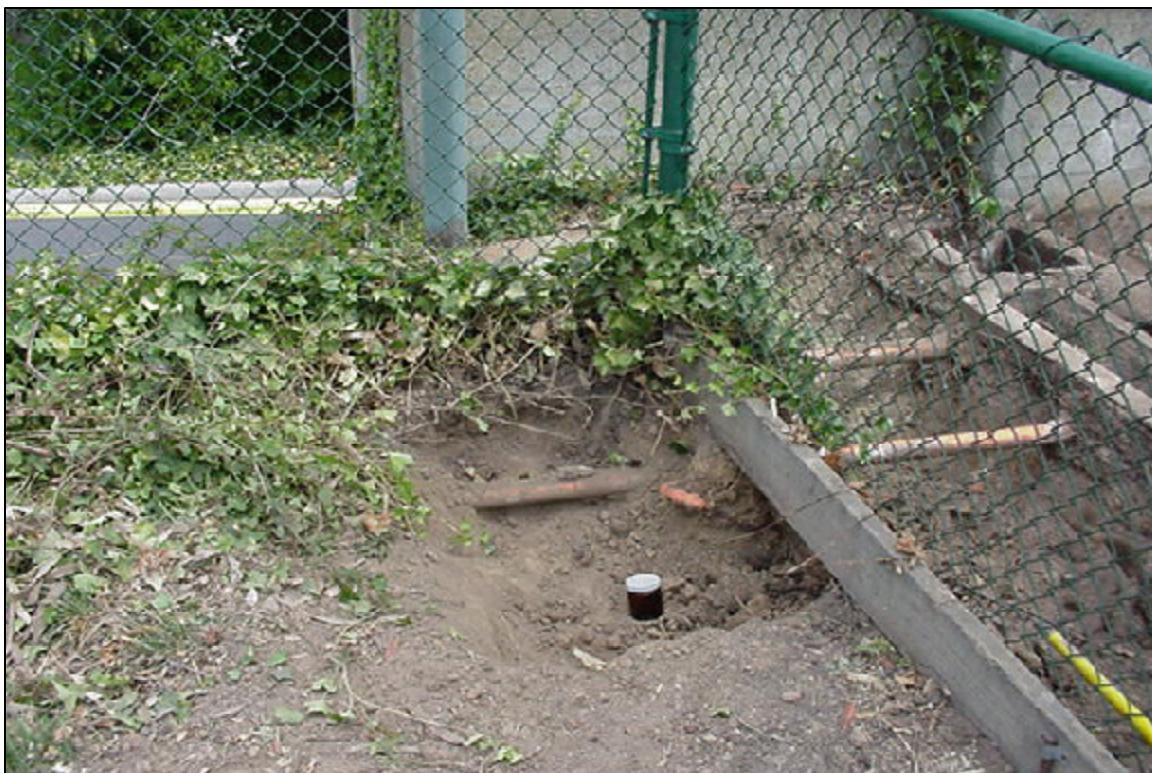
Photograph 13: Excavation at the corner of Tower Park Playground.

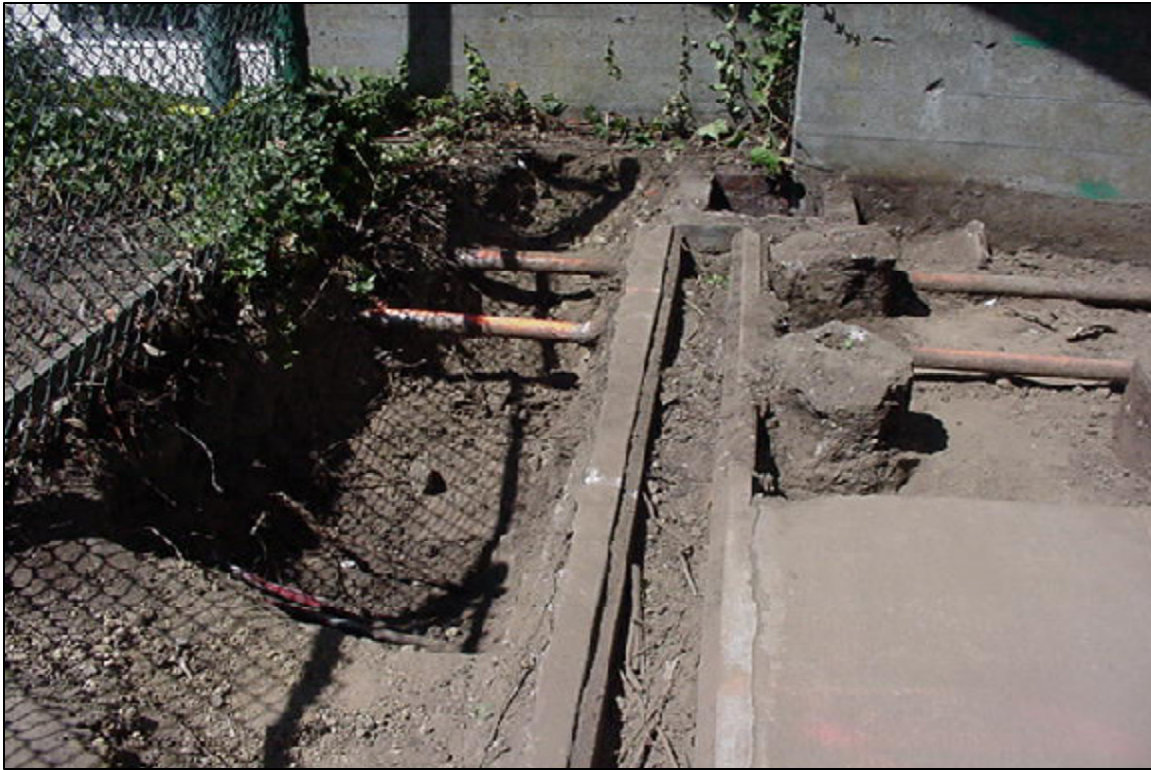
Photograph 14: Excavation adjacent to Tower Park Playground and west of steam line support pole.

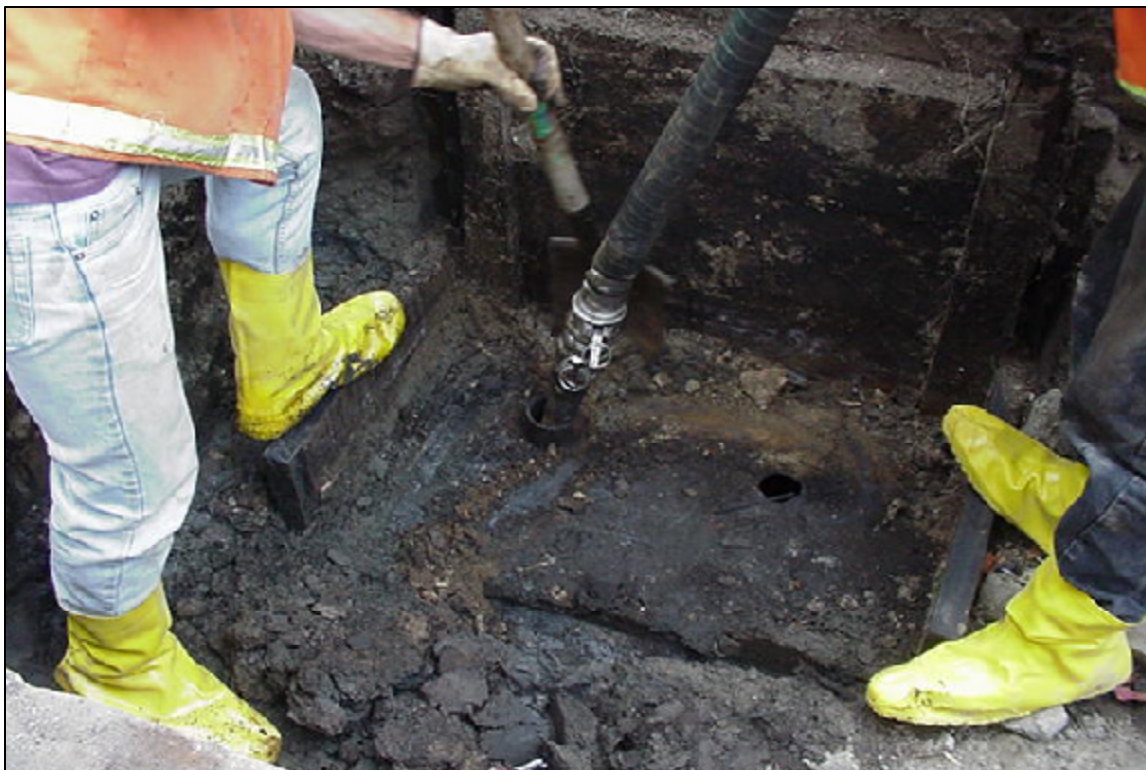
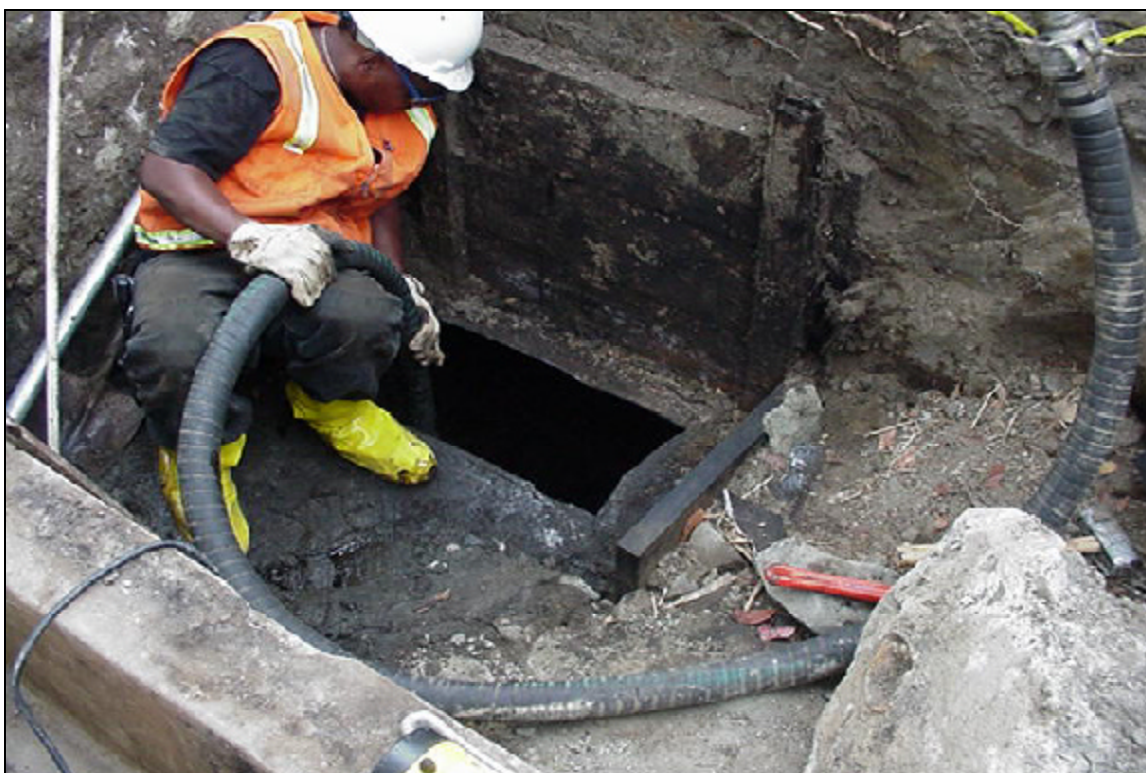
Photograph 16: Removal of UST contents.

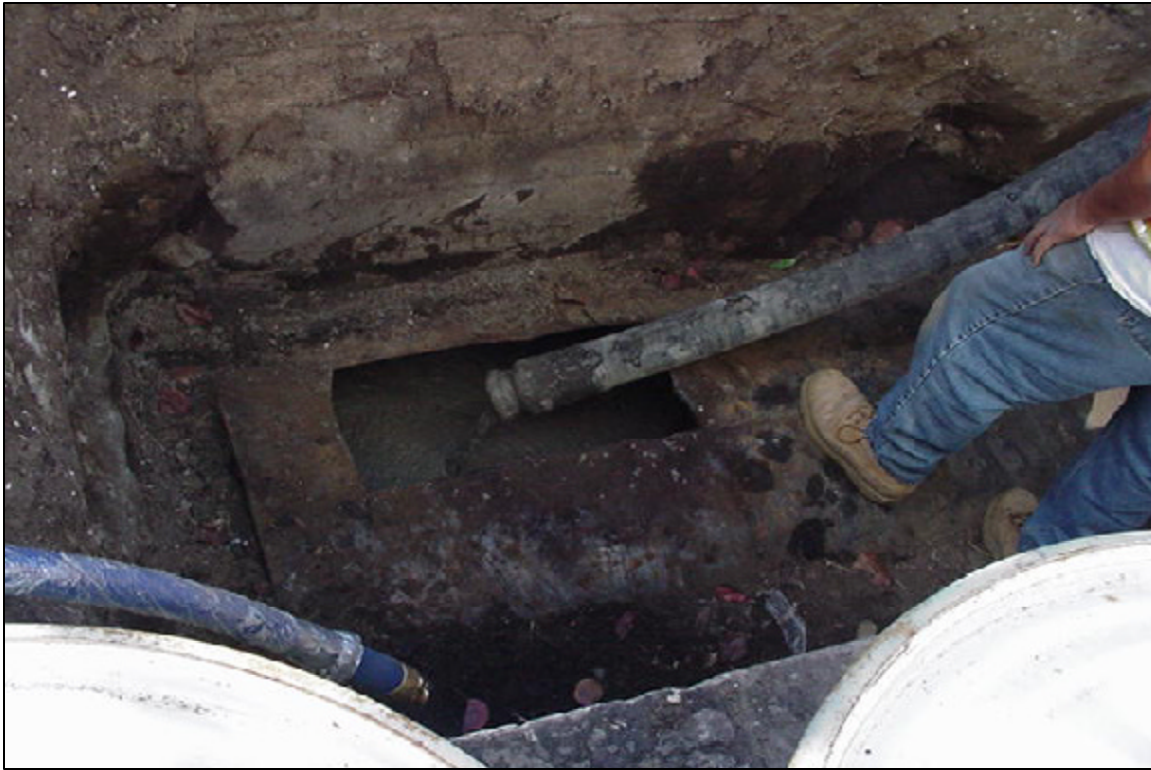
Photograph 18: Filling UST with sand/cement slurry.

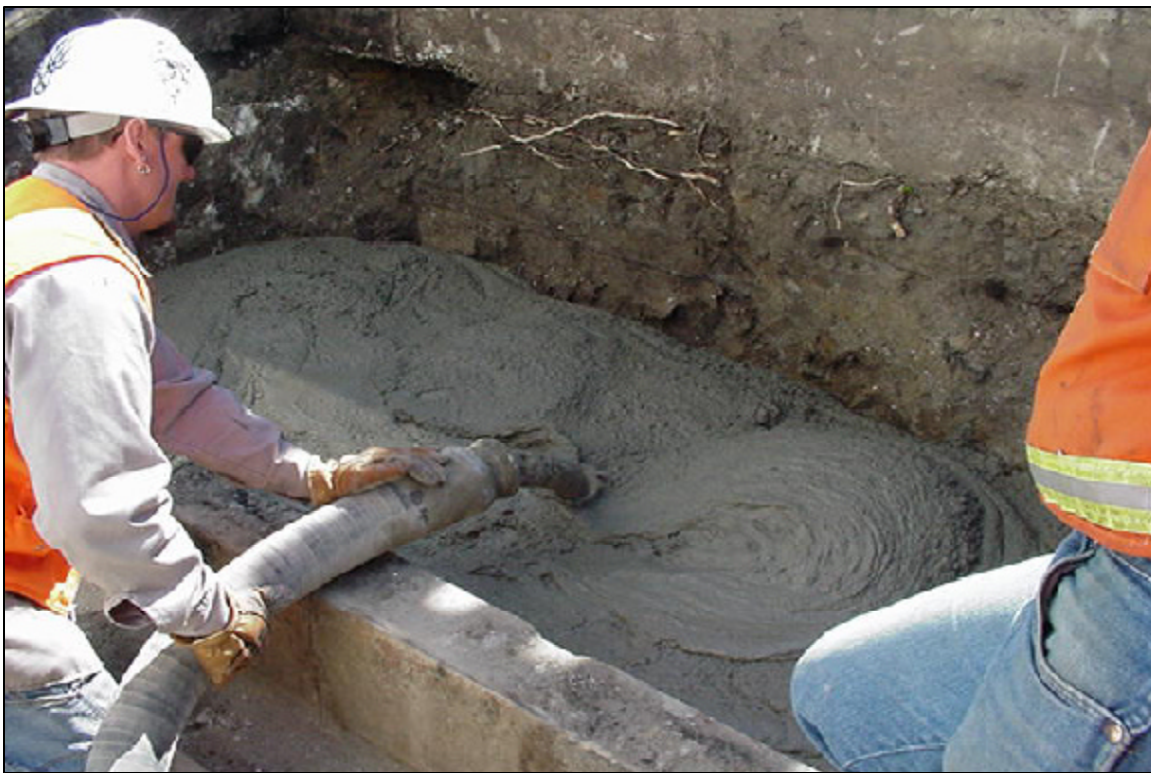
Photograph 19: Filling excavation above UST with sand/cement slurry.

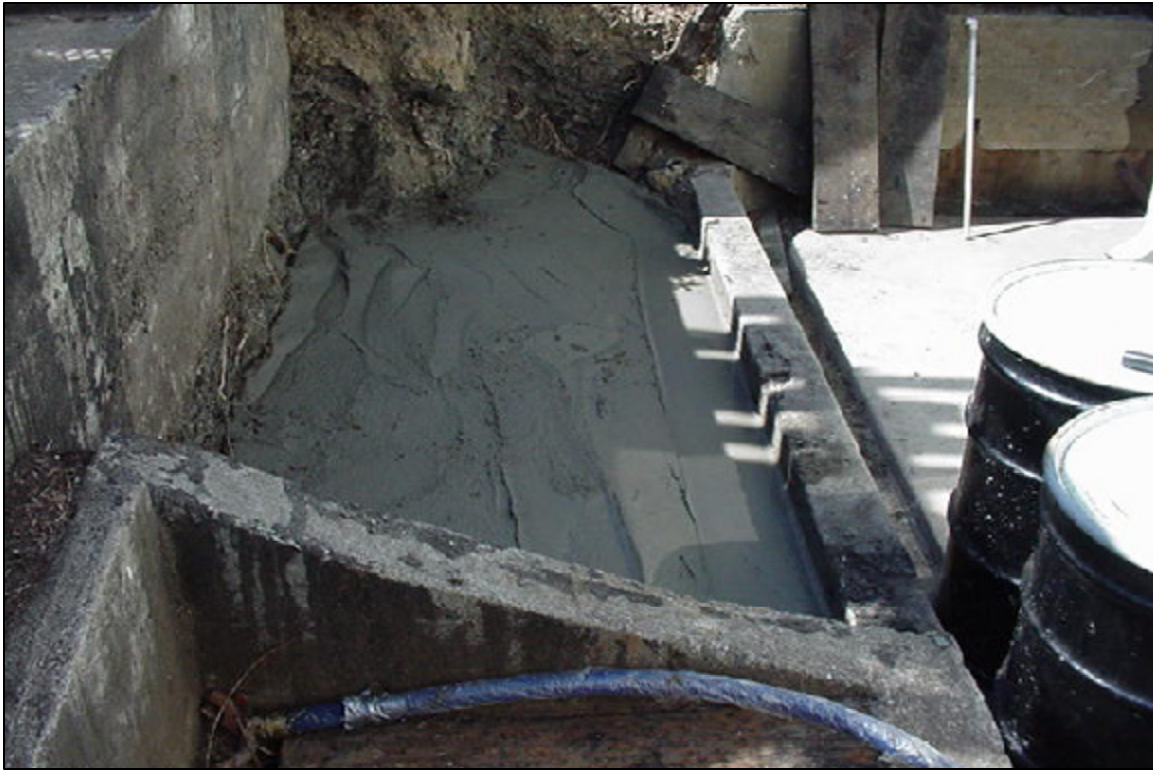
Photograph 20: Filled excavation above UST.

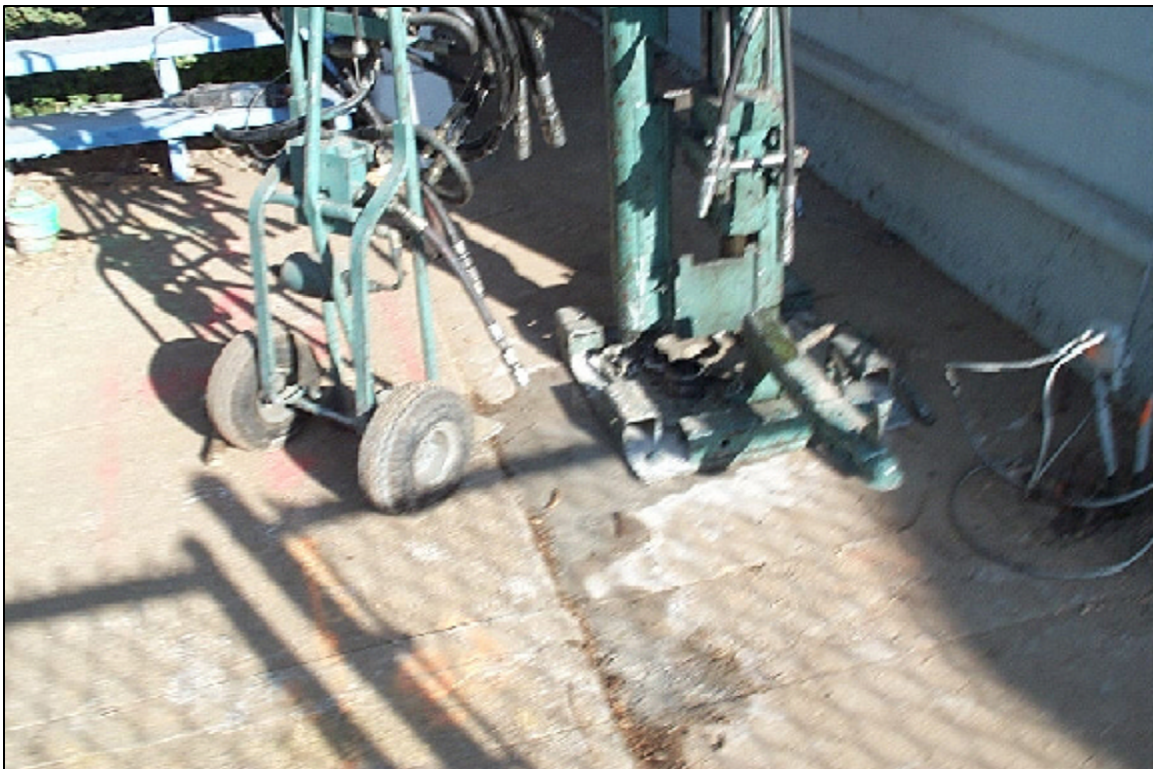
Photograph 21: Drilling activities at northwest corner of building.

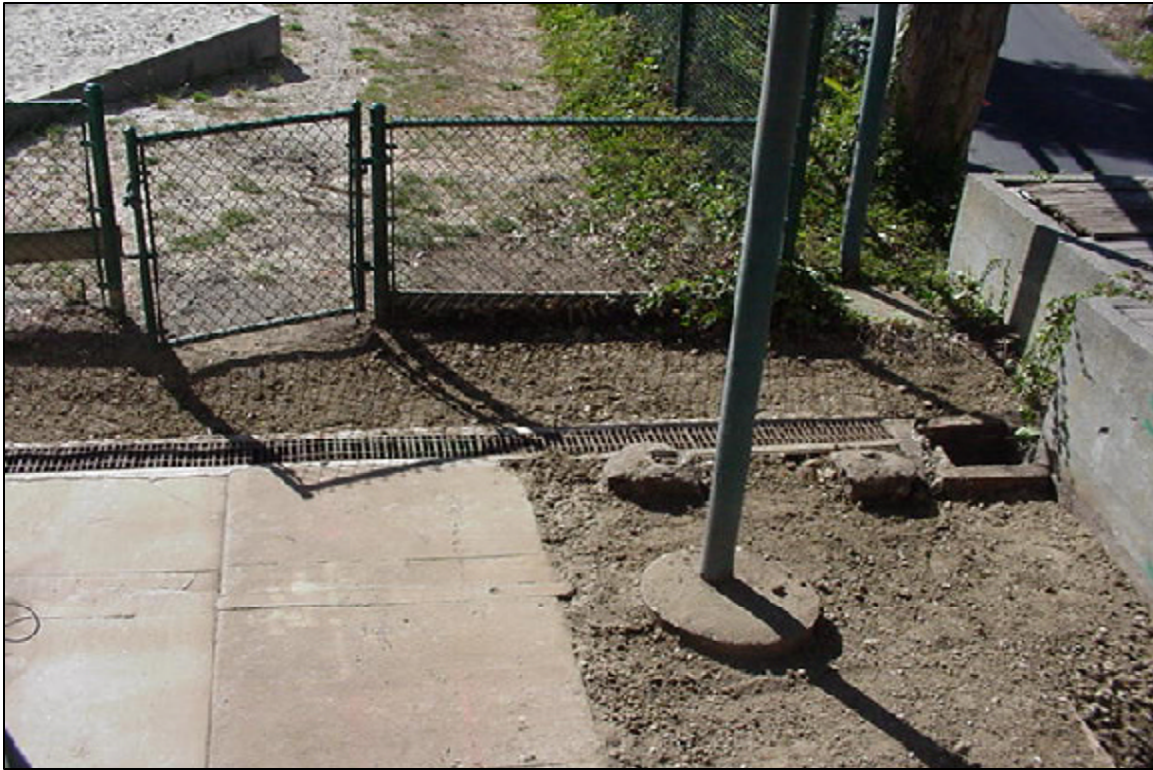
Photograph 22: Restored view of northwest corner of building.

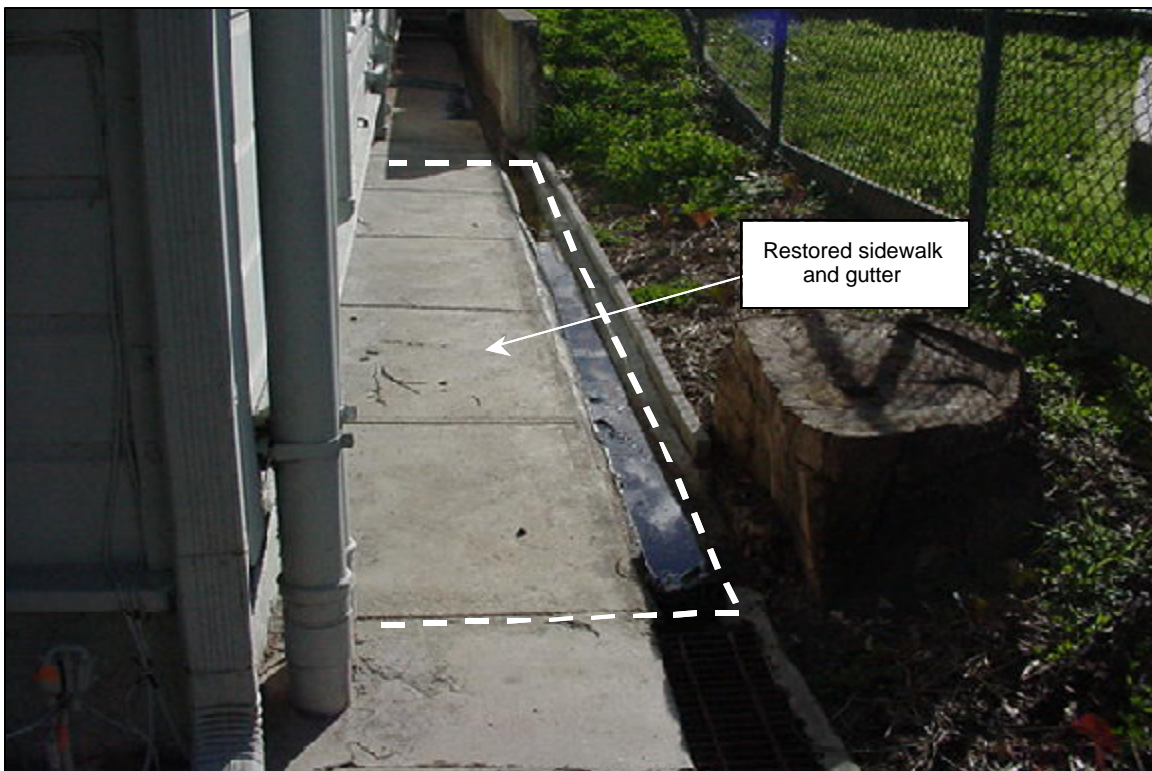
Photograph 23: View looking south along the western wall of Building 66 showing the restored concrete sidewalk and storm gutter.

Both the 65 square feet of 3-inch concrete sidewalk and the 25-foot long gutter were replaced along the west wall of Building 66 ([Photograph 23](#)). All other excavation areas previously covered with soil were returned to pre-excavation conditions, including the area overlying the UST ([Photograph 24](#)) and the northwest corner excavation area. The stairway landing at the northwest corner of the building was restored to its original condition ([Photograph 25](#)).
